Assessing hiking trails condition in two popular tourist destinations in the Icelandic highlands

Rannveig Ólafsdóttir ^{a,*}, Micael C. Runnström ^{b,1}

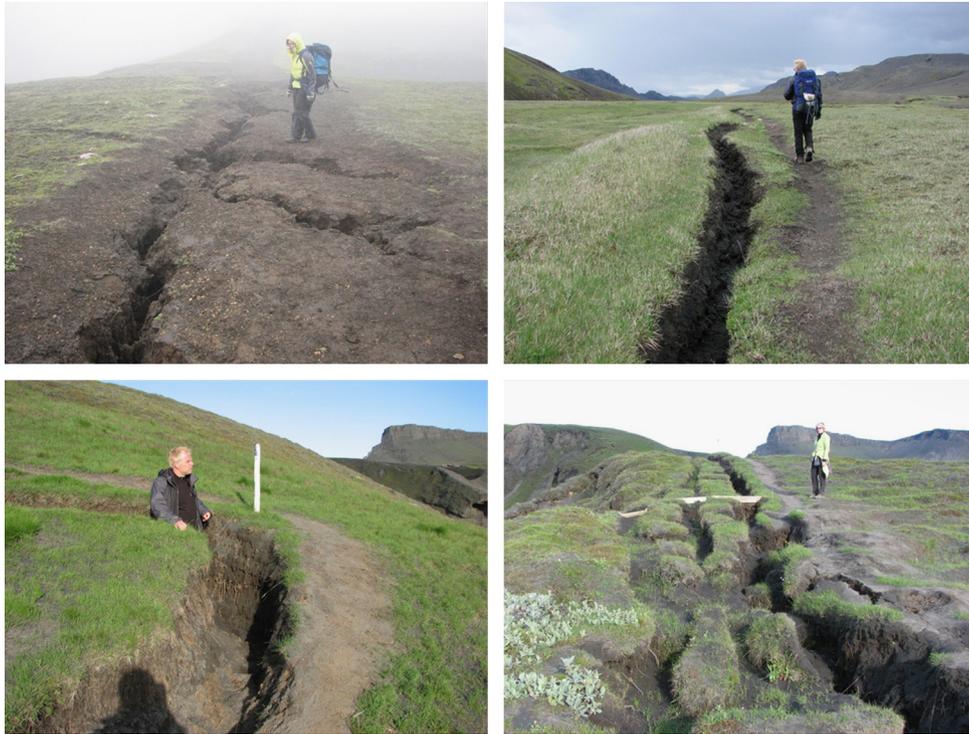
Fig. 4. Examples of severe hiking trail degradation in the study areas (Photographs Rannveig Ólafsdóttir & Micael Runnström).

Less than half (41%) of the hiking trails assessed within the Þórsmörk area are classified as being in good or very good condition. A total of 29% are in acceptable condition. Trails classified as bad or very bad amount to 30% and 12% respectively (see Fig. 4 for

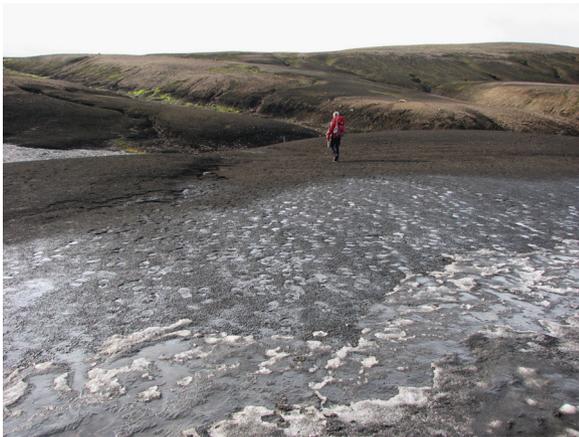
Fig. 5. Large impact zone as a result of a hiking trail on a flat unvegetated surface close to Landmannalaugar (Photograph Rannveig Ólafsdóttir).

Furthermore, when designing recreational hiking trails in the Icelandic highlands, special care should be taken when planning trails on slopes, especially in moss and moss-heath covered slopes. Wherever possible, planners should avoid steep slopes when designing new hiking trails. Overall, our study clearly indicates that the number of hikers is the major factor of trail deterioration. Therefore it is of fundamental importance to control the number and flow of visitors in the most vulnerable areas. Visitors can be managed by restrictions, or alternatively by informational signs targeting the environmental conscience of visitors by informing about the area's ecological vulnerability as well as the effects of their own trampling on such an ecosystem. It is also crucial to maintain hiking trails at all times so that it is more likely for hikers to stay on the trail and pre-empt the spreading of a larger impact zones. In the Icelandic highlands where the trails are usually marked with wooden poles, it is important that the distance between the poles is close enough so that the hikers can easily navigate from one pole to the next. This is especially vital in flat areas where trails tend to spread out and consequently quickly disturb a much larger area.

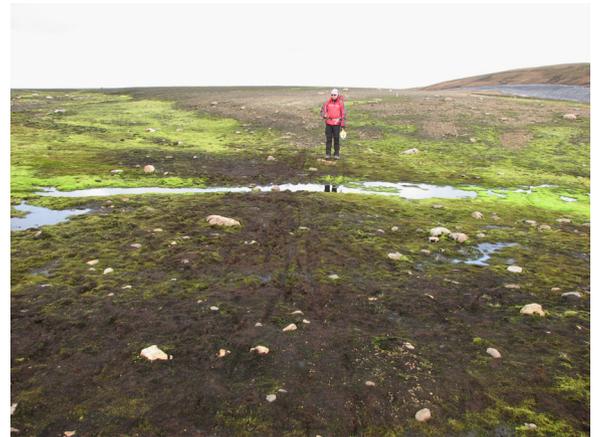
Fig. 6. Severe impact of a hiking trail traversing the patchy mossy vegetation that characterizes large areas of the Landmannalaugar hiking trail system (Photograph Rannveig Ólafsdóttir).
